Alternative Repair of a snapped Middle Drive Shaft (Yamaha BT-1100 Bulldog)

- Repair by a Yamaha workshop will cost you at least 2500€ -

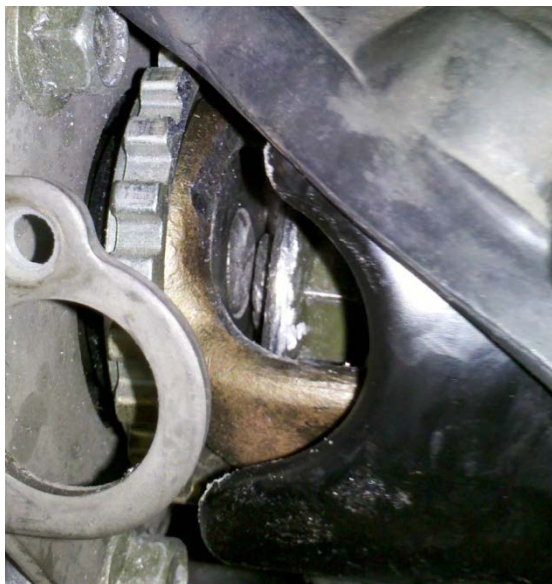
Picture 1. First Inspection:

In case it looks like the picture at left, you are in trouble. The middle drive shaft has snapped.

How did this happen? The author is of the opinion that this is what happened: The nut that holds the yoke of the universal joint has loosened slightly. Now, the yoke can move freely over the splines of the shaft. The author has observed that it can also tilt slightly. When driving, this will result in a slightly wobbling yoke. The wobbling yoke exerts a force at the outer rim of the nut. The nut flange has a rela-

tively large diameter and acts as a lever. The result is a continuously repeating bending force being exerted on the shaft. The shaft has not been designed to cope with this kind of load and snaps. The yoke slides backwards and tilts even more. The yoke and the nut now start to hit the speed sensor and other nearby parts.

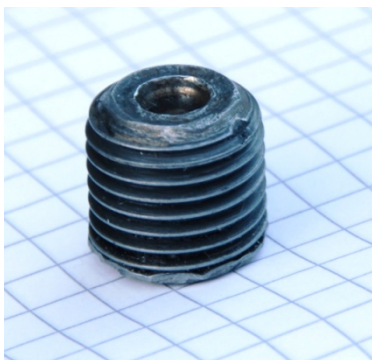
Picture 2. According to the workshop manual, the nut should have been secured by applying Loctite and by staking. The author did not observe any traces of Loctite and staking was done inadequately. Picture 2 shows how staking was done. The dent in the thread has no effect at all, the nut was observed to move freely over the broken end of the shaft.

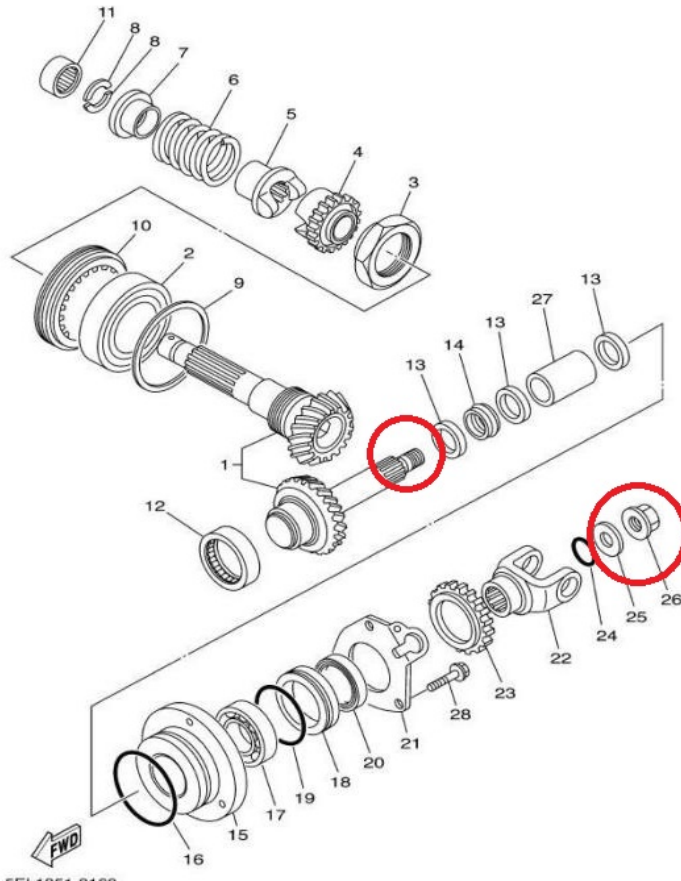
Picture 3. So, what to do next? Yamaha still is in the phase of denial of the problem, does not take any responsibility for the consequences and the Yamaha workshops will charge you at least €2500 for repair. The repair involves disassembly of the complete engine to replace the middle drive (#1 in Picture 3).

Luckily, the forum in the USA describes a method of repair that can be done without taking the engine apart. The [V-Star Forum](#) describes how the function of the nut can be taken over by a M8 bolt, after a M8x1.25 inner thread has been tapped into the snapped shaft. The only function of nut (#26) is to retain yoke (#22) on the middle drive shaft. Forces acting will be forward forces exerted by the 90 degree middle drive gear and backward forces that result from the drive shaft during movement of the

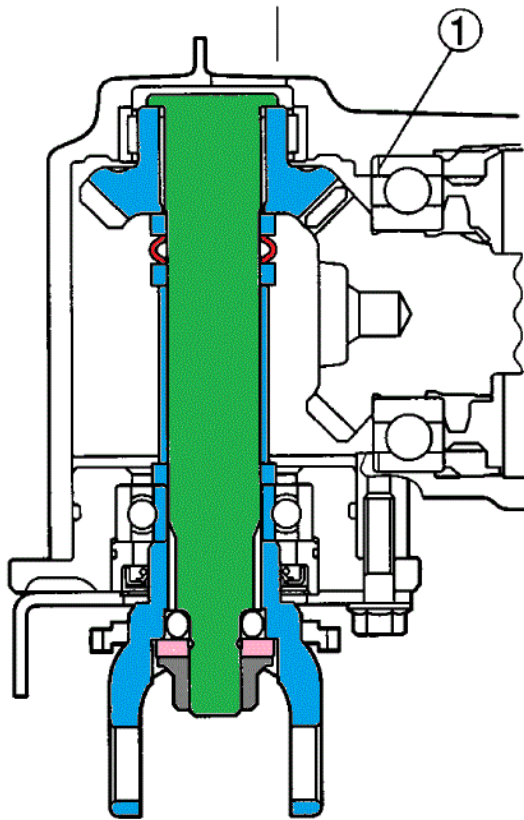
Picture 10. As stated before, the workshop manual from page 4-78 onwards describes the issue of backlash. Collapsible ring (Red in picture 10) plays an important role in positioning of the drive shaft. At first assembly, the nut is tightened such as to create the desired amount of backlash. The collapsible ring is slightly compressed in this procedure. The author never had the opportunity to study a collapsible ring in detail, but from reading the workshop manual and considerations regarding the role of the ring the author draws the conclusion that this ring is not easily compressed, nor flexible. So, it should retain its compressed status and will only be further compressed if significant forces are applied (that is, when the newly installed hex nut is fastened with high torque).

The author therefore is of the opinion that the backlash as set when the engine was first assembled will be restored when the hex bolt is tightened with mild force.
