Alternative Repair of a snapped Middle Drive Shaft (Yamaha BT-1100 Bulldog)

- Repair by a Yamaha workshop will cost you at least 2500€ -

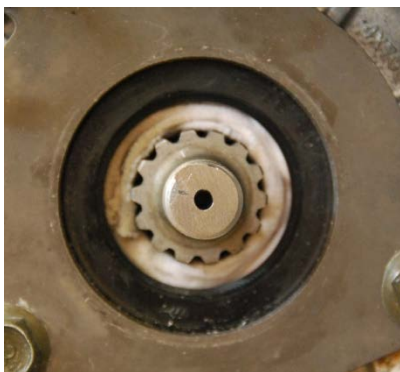
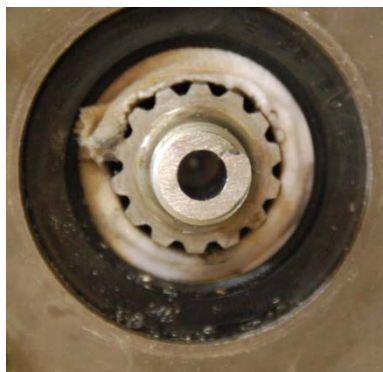
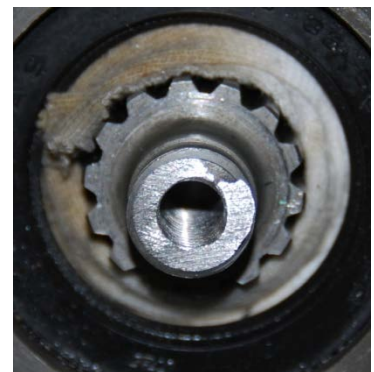
- 1) The snapped shaft may be too long to allow for the repair as described here. In that case, applying the bolt will result in a situation as shown in the far right of the three pictures above. The washer rests on the snapped shaft, and as a consequence, the yoke still is able to move slightly. So, make sure that the situation as depicted in the middle can be realised. This is best checked while the "O"-ring (#24 in picture 3) is not yet in place. If too long, the snapped shaft should be shortened by filing or grinding. Beware of debris entering the engine.
